Subject: Capacitor Required with Some Wiegand Readers

Issued: August 15, 2008

Products Affected: **nPort-R1 Single Door Controller**

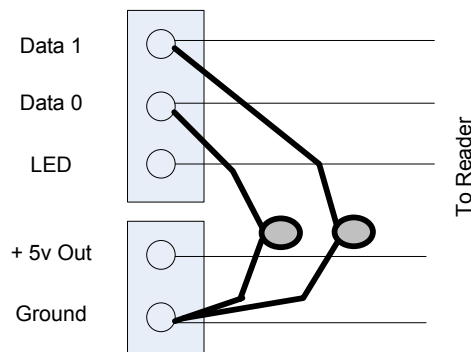
Problem: In certain situations, the card reader signal is not being interpreted correctly by the nPort access controller. The result is an incorrect card number being sent to the system. This can be verified using the Door Status/Access tab in the Inspector Application (version 2.0 of nSecure software).

Example: *Card number 12 was being used at the card reader, but card number 4096 was being displayed at the software.*

How to Fix: Place a **.1uf ceramic capacitor** between reader ground and data 0 input and a second .1uf capacitor between reader ground and data 1 input. This should be done on the blue connector where the reader terminates inside the nPort controller.

The .1 (point 1) uf (microfarad) capacitor can be purchased from Radio Shack.
